<u>Sailplane model:</u>	H 301 Libelle und H 301 B Std.Libelle, Std.Lib. 201 B, Std.Lib. 203 Club Libelle 205 und Hornet Kestrel Glasflügel 604 BS I	ATC No. 251 251 304 276 281
-------------------------	--	---

Subject : Glass fiber laminate covering the spar stub fittings

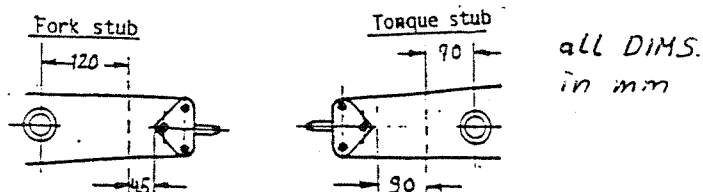
2. If corrosion was found on the fitting, proceed as follows:  
First remove gelcoat from spar stub (if such was applied by the manufacturer) and remove laminate as shown in the sketch (such preparing the area to be scarfed later on) -

make sure that the spar flange rovings and the laminate connecting the upper and lower stub halves are never been sanded. Furthermore remove any laminate adhering to the fitting.

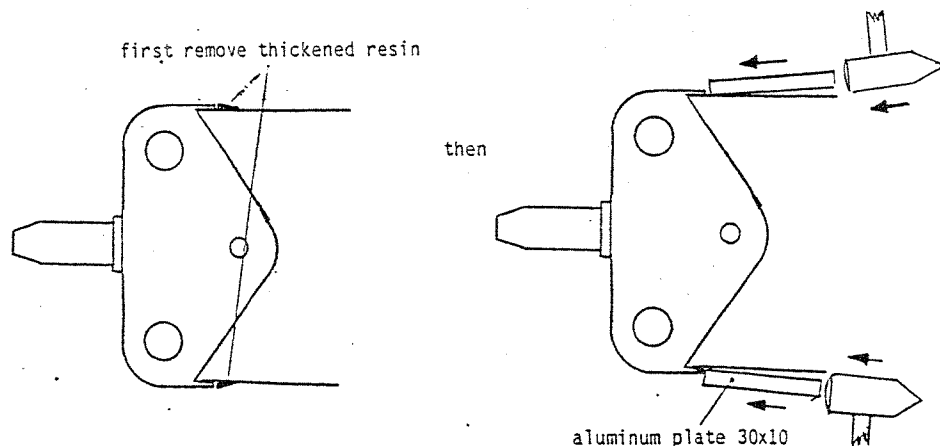
If there is suspicion that there is corrosion on the inner side of the fitting, it has to be removed as follows:

Drive out hollow rivets imbedded in the spar flanges - but make sure that a counter weight is held against the driving force, Thereafter, with rivets removed, carefully loosen and extract the fitting with the aid of an aluminum plate - see sketch.

Next sandblast the fitting (Using only approved material) and apply a fresh corrosion protection. Then carefully smooth the spar stub (using a 400 grid sand paper), apply a thin coat of resin, push fitting fully home and install hollow rivets. The step between fitting and stub and between connecting glass layers should be filled up using thickened resin.
