Subject: Aileron actuating shaft

Affected: Sailplane model: Standard Libelle, Standard Libelle 201B, Standard Libelle 203  
All serial numbers

Reason: Cracks on aileron operating lever's welding seams due to overloading in case of derigging without disconnection of aileron controls.

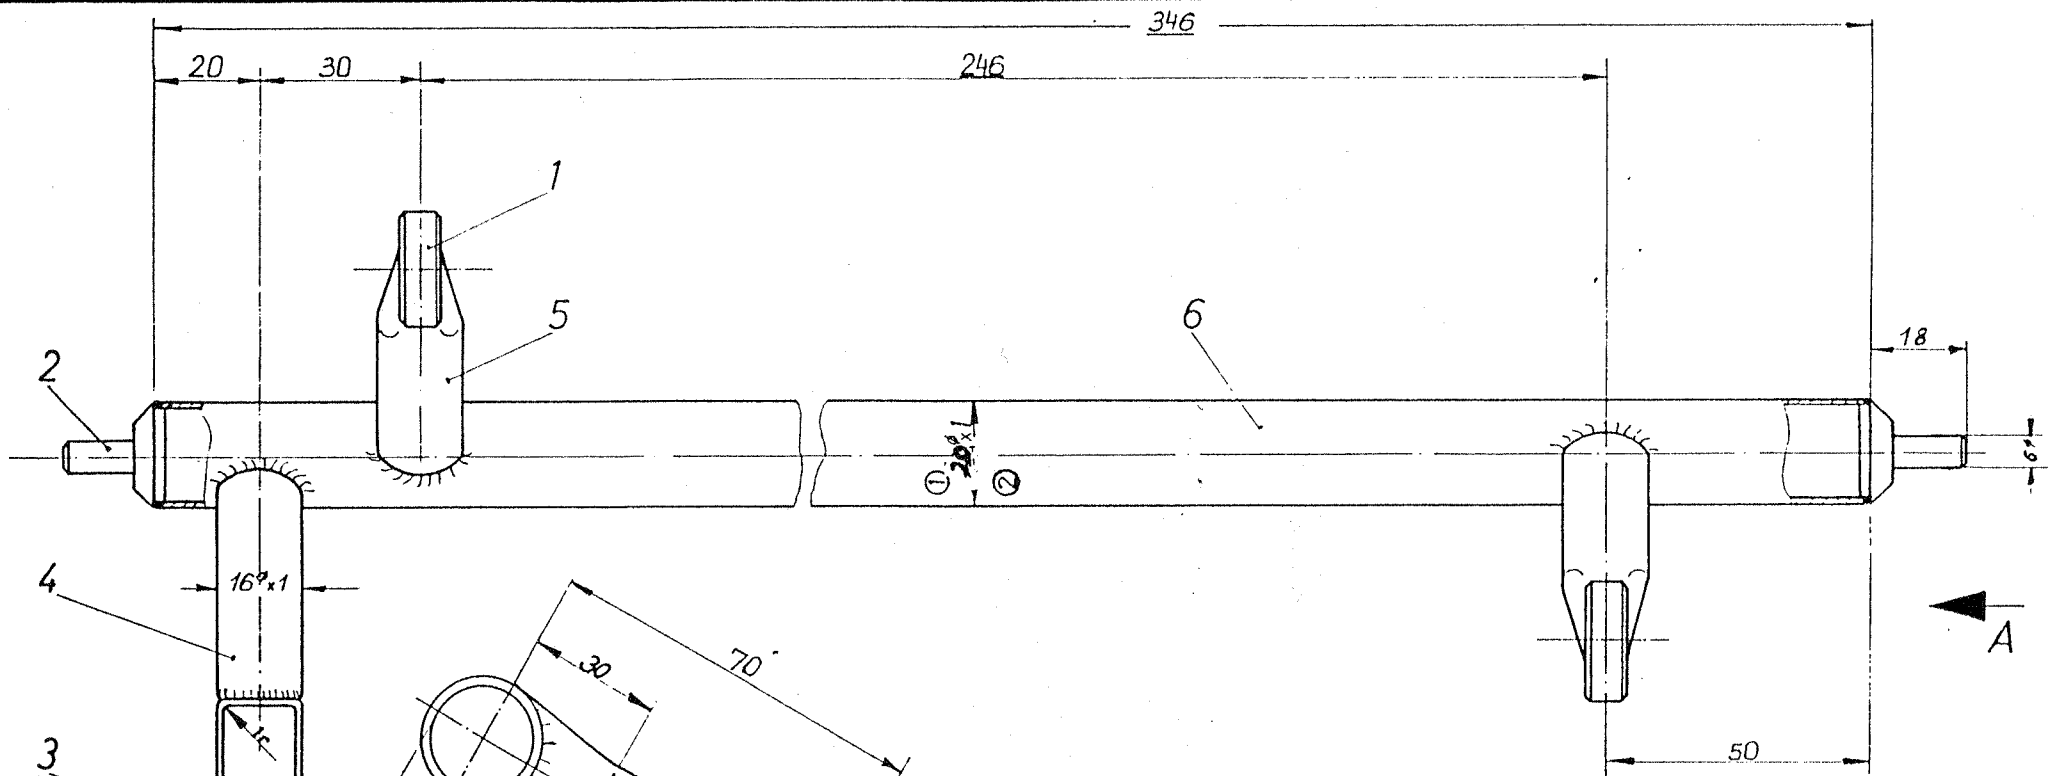
Maßstab		<b>Gr. Antriebswelle</b> <b>Aileron actuating shaft</b>	<b>201-47-3</b> Techn. Mitteilung 201-33 Blatt 2/3
---------	--	--	--

Method 1: Before the next flight the aileron actuating shaft in the fuselage (see drawing no. 201-47-3 enclosed) must be checked by a licensed inspector nearby the welding seams using an electric torch and a magnifying-mirror (min. double magnification). Overloading of the joint might be indicated e.g. by local paint peeling. If there is any damage in suspect the actuating shaft must be removed and subjected to a magniflux inspection. Magniflux inspection must be done by a licensed aircraft maintenance and engineering service using a inspection procedure proved and permitted for aviation use. If there are no hints on cracks or any other damage flying operation can be continued until 31.12.96. After this date instructions according to either method 2 or method 3 must be accomplished.

Method 3: If method 2 was not accomplished the original actuating shaft can be replaced by a new and reinforced shaft according to drawing no. 201-47-3, Change "2".
