<u>Sailplane model:</u>	H 301 Libelle und H 301 B Std.Libelle, Std.Lib. 201 B, Std.Lib. 203 Club Libelle 205 und Hornet Kestrel Glasflügel 604 BS I	ATC No. 251 251 304 276 281
-------------------------	--	---

Subject : Glass fiber laminate covering the spar stub fittings

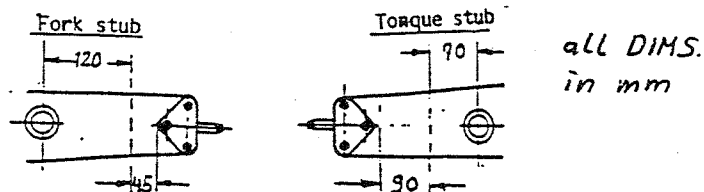
2. If corrosion was found on the fitting, proceed as follows:
First remove gelcoat from spar stub (if such was applied by the manufacturer) and remove laminate as shown in the sketch (such preparing the area to be scarfed later on) -

make sure that the spar flange rovings and the laminate connecting the upper and lower stub halves are never been sanded. Furthermore remove any laminate adhering to the fitting.

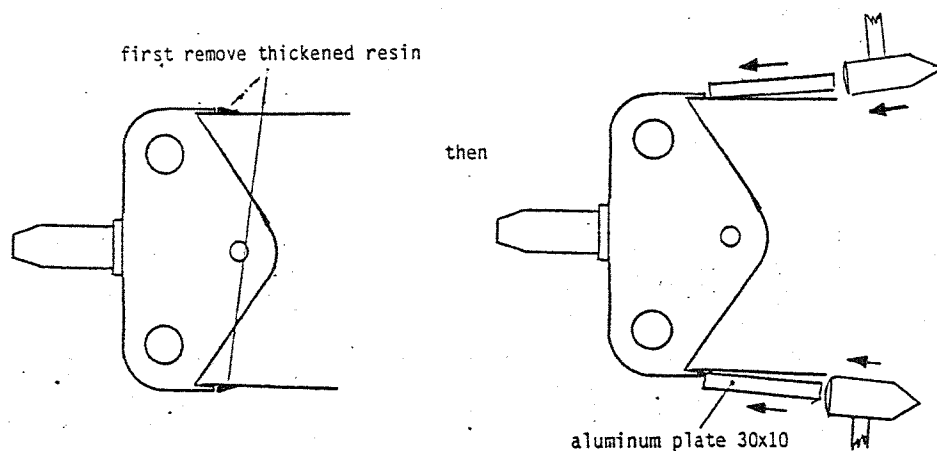
If there is suspicion that there is corrosion on the inner side of the fitting, it has to be removed as follows:

Drive out hollow rivets imbedded in the spar flanges - but make sure that a counter weight is held against the driving force, Thereafter, with rivets removed, carefully loosen and extract the fitting with the aid of an aluminum plate - see sketch.

Next sandblast the fitting (Using only approved material) and apply a fresh corrosion protection. Then carefully smooth the spar stub (using a 400 grid sand paper), apply a thin coat of resin, push fitting fully home and install hollow rivets. The step between fitting and stub and between connecting glass layers should be filled up using thickened resin.
