<small>STANDARD 1000          200 500 1000 1500          LBA-NO. 301-33-8</small>	Modification number 25 Aircraft type H 301 "Libelle"	Page 1 Number of Pages 2
---	---	-----------------------------

Description: Locking guide for elevator assembly  
 Drawing -No. 301-33-8

Höhenruder-Montagesicherung  
Horizontal Tail Assembly Guide

Änderung  
Nr. 25  
Blatt 2

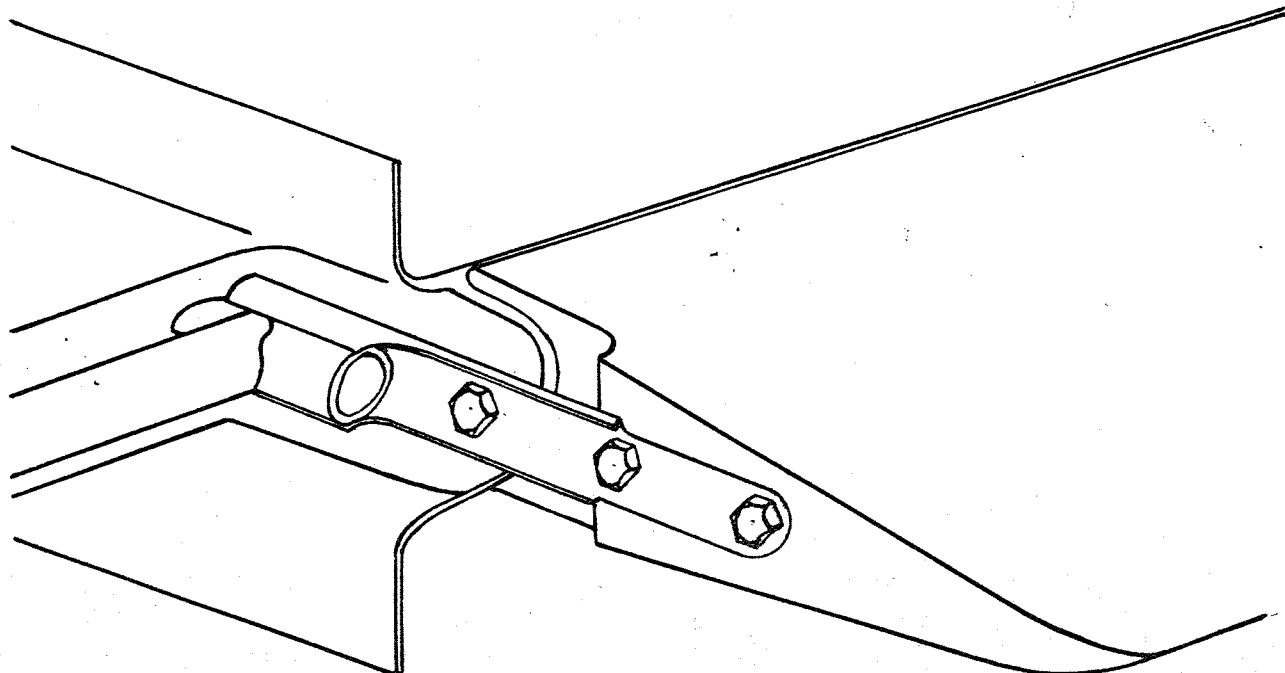
Ausführung bis Werk-Nr. 85  
construction through serial-number 85

Inserting horizontal tail into fin, an improper assembly is possible. The installation of elevator locking guide prevents this.

Teilansicht des Höhenleitwerks, R-Höhenruder-Hauptbeschlag  
sectional view of horizontal stabilizer, RH-elevator-main fitting

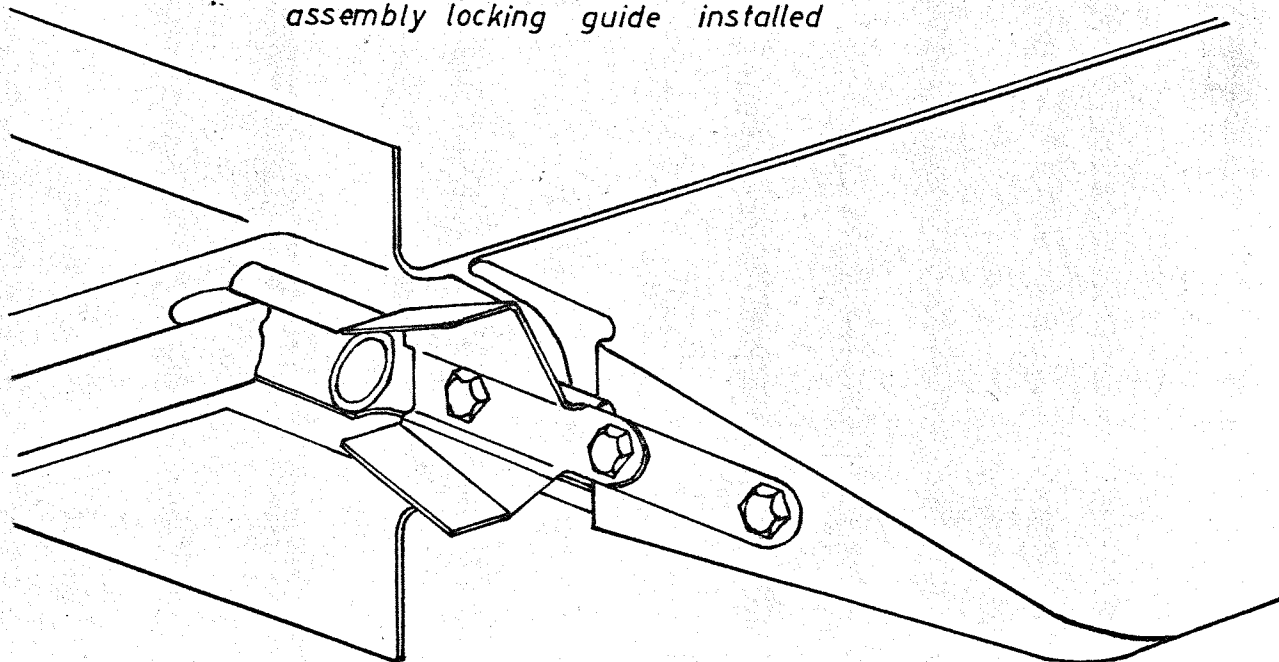
Sicherung eingebaut!  
assembly locking guide installed

Elevator locking guide must be installed on the left or right side of horizontal stabilizer in accordance with page 2 of modification. Drawing and parts may be obtained from GLASFLÜGEL, ING. EUGEN HÄNLE, 7311-SCHLATTSTALL/WTTBG./GERMANY

Remove both front bolts of elevator main fitting and take care, that washers on both sides of the ball bearing don't drop.

Reinstall elevator locking guide and fitting according to page 2.

Now check the guide when assembled for freedom of operation.
