Subject: Elevator Linkage at the base of the stick

Affected: Glider-Model: H 301
H 301 B

Reason: All Works Nos.
Failure of a Linkage

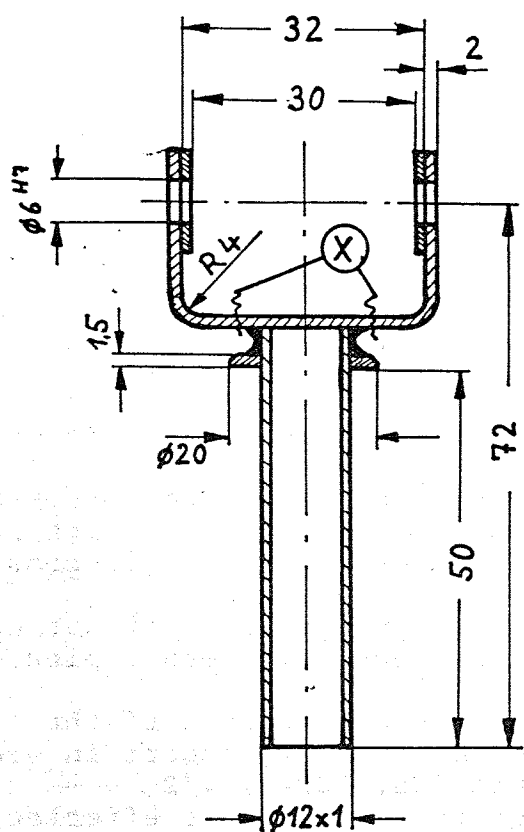
Action 1: The Elevator Linkage at the base of the stick (see modified drawing No. 301-41-4/2) must be inspected carefully by means of a magnifying glass (magnification at least 5x) for possible cracks near the welded seam. This inspection must be made immediately and again following the application of high loads to the glider (e.g. hard landing or ground loops). If cracks are found the glider must not be flown until the defective part has been replaced.

(X) Position of possible cracks on original Elevator Linkage

Action 2: The Elevator Linkage at the base of the stick must be replaced by a modified part in accordance with drawing No. 301-41-4/2 Replacement must in all cases be effected until November 1st 1980.

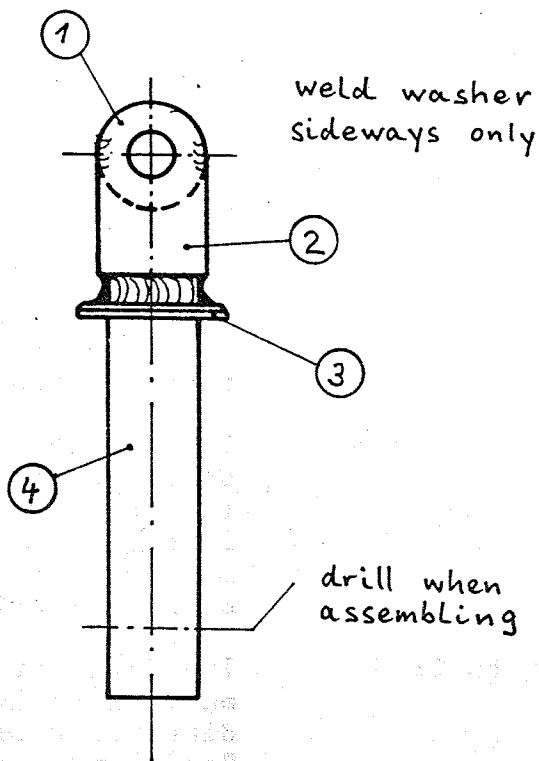
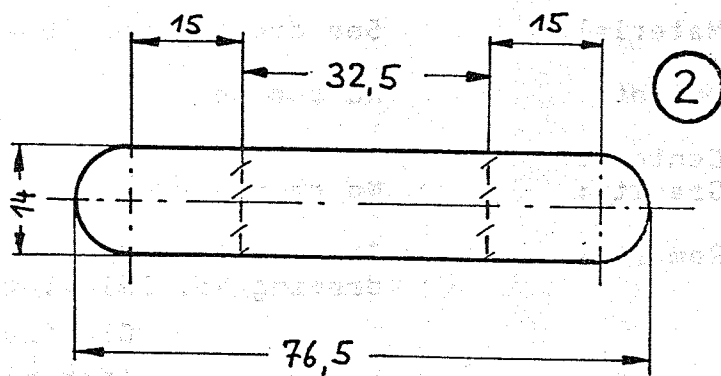
301-41-4/2

- ① washer (2x) St $\varnothing 14 \times \varnothing 5,5 \times 1$
- ② frame 1.7734.4 76,5 x 14 x 2
- ③ washer St $\varnothing 20 \times \varnothing 12 \times 1,5$
- ④ tube 1.7734.4 $\varnothing 12 \times 1 \times 56$

heat-treatment after welding: Tempering in controlled atmosphere
1 hour at 550°C
