GLASFLÜGEL

AIRWORTHINESS DIRECTIVE

NO. 303 - 9

Subject Canopy emergency jettisoning system

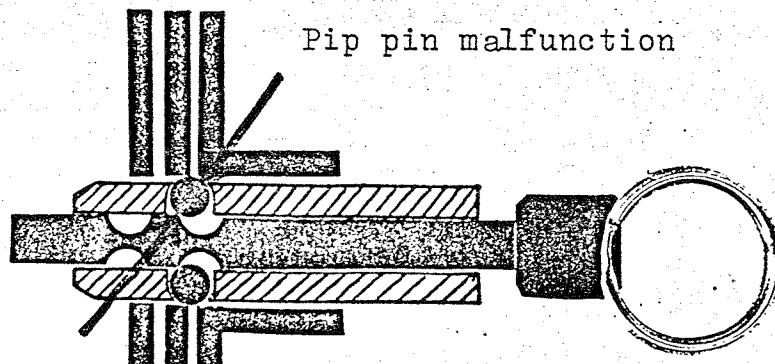
Reason During a routine check it was discovered, that either of the "Pip pins" of the canopy jettisoning system, which disengage when the red knob is pulled, could become jammed, if they had not been previously fully pushed home.

Fehlfunktion

Action On page 19, § 3.3, of the Flight Manual the following amendment must be inserted:
"Whenever the canopy emergency jettison knob is pulled and prior to each flight, if no locking thread is used, it should be ensured, that the Pip pins are fully pushed home, so that the locking balls are clear of and behind their fittings".
