Subject : Elevator drive

Affected : Sailplanes model "Club-Libelle 205" } F.R.G. Type Certif.
"Hornet" } No. 304
"Mosquito" } F.R.G. Type Certif.
"Glasflügel 304" } No. 318
- all variants, all serial numbers

HR - Antrieb
Elevator drive bracket

205-33-9

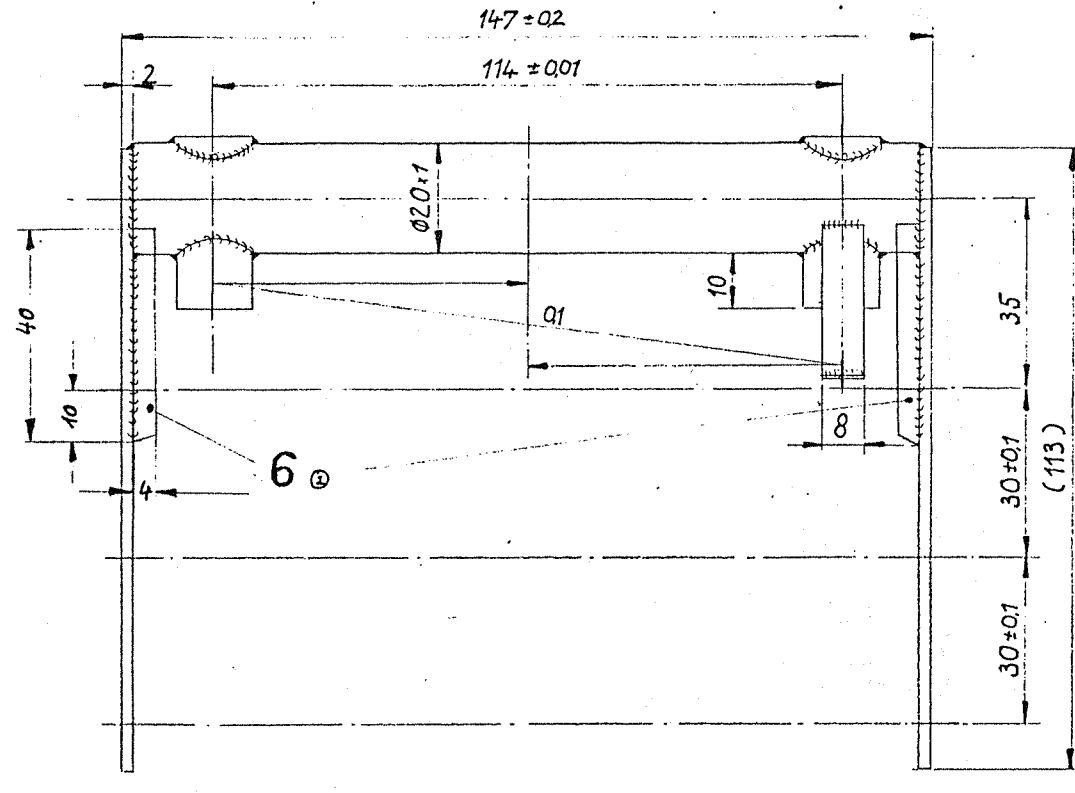
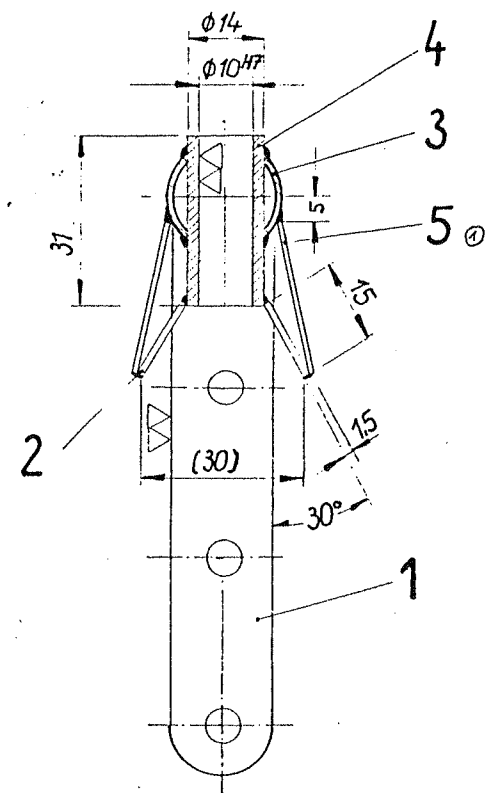
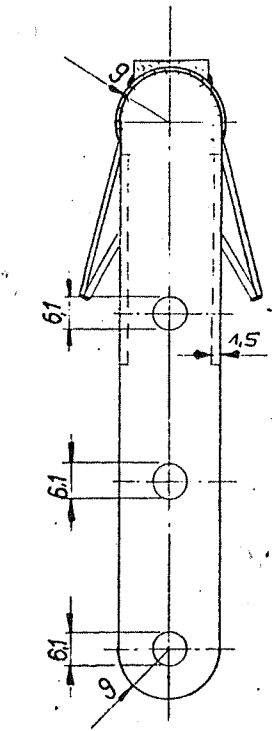
Reason : Difficulties in the control of the sailplane were encountered when an elevator drive bracket broke on one side in flight.

Actions : 1. On sailplanes having an earlier type elevator drive bracket (without reinforcements identified as part ⑥, modif. 2, on the drawing shown overleaf), a visual inspection for possible cracks in the bracket arms must be carried out. It must also be checked that the bracket arms are not twisted out of line.
2. On sailplanes having an earlier type elevator drive bracket (without reinforcements), the bracket must either be reinforced according to the drawing shown overleaf or be replaced by a reinforced bracket. When the tailplane is re-assembled, it must be made sure that the correct number of spacing washers are fitted between the bracket arms and the ball bearings (tag washers when removing the bracket).

Materials : The reinforced elevator drive bracket, manufactured according to drawing No. 205-33-9 (modification 2) or the additional metal strips with welding wire 1.7734.2 may be obtained from:
Hansjörg Streifeneder
Glasfaser-Flugzeug-Service GmbH
Hofener Weg
7431 Grabenstetten
Federal Republic of Germany

Note : Welding according to drawing No. 205-33-9 (modification 2) must be done by a licensed aircraft welder.
Accomplishment of action 1 must be done by a skilled person.
Accomplishment of action 2 must be entered in the sailplane's log by a licensed inspector.
