Reference Glider model GLASFLÜGEL " K E S T R E L " (17m)
German Data Sheet No. 276
Serial- No. affected: 25 through 129

Subject Dive brake control system in both wings

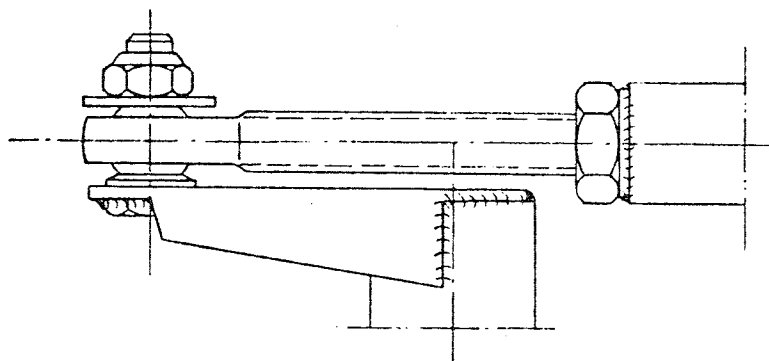
Reason Failure of a dive brake control rod end in the welded area caused operational problems

Remarks Replacement of control rod ends is easily accomplished through rear root rib access holes. New rod ends are installed according to the sketch below:

Method Welded control rod ends as per drawing No. 201-56-22 linked to the dive brake bevel gear must be replaced by new machine lathed rod ends according to drawing No. 401-56-23

By adjusting the rod end length the locking force should be adjusted so that the over-centering moment at the bevel gear actuator head does not substantially exceed 1 da Nm. In order to measure this moment the fuselage dive brake actuator tube may be removed temporarily and used for this purpose.
