Subject: Airbrakes actuation shaft

Affected: Kestrel

At every annual inspection, check the welding joint area of the airbreak actuation lever on the torsion tube according to TN 401-26.

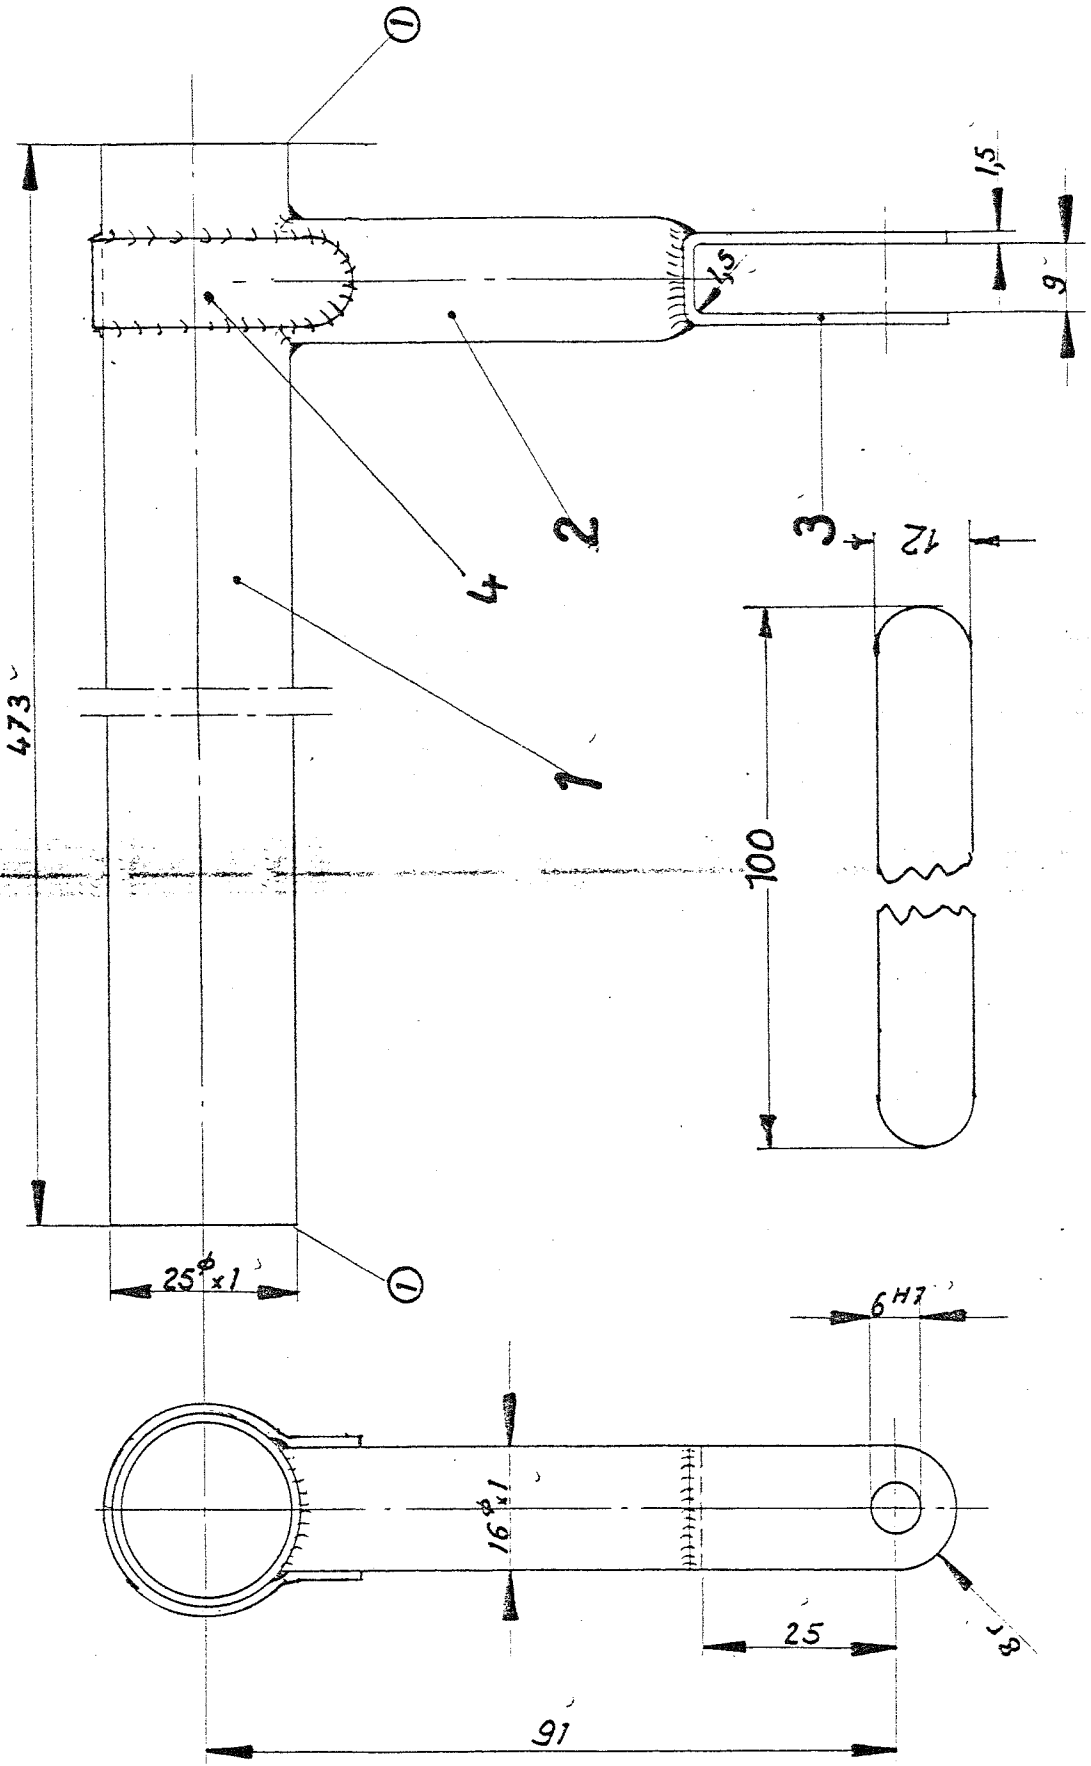
Material: See drawing no. 401-56-3-1

Reason: Deformation and cracks caused by incorrect locking forces of the airbrake control shaft

4. If damage is found during completion of step 1 or 3, the airbrake actuation shaft must be immediately removed. The welding seam area must be thoroughly cleaned and all paint removed. In case of visible deformation, the actuation lever must be heated and returned to the original position. Visible cracks may only be welded by a licensed aircraft welder within a licensed and appropriately equipped aircraft maintenance organisation. Afterwards no. 4 must be properly welded in accordance with drawing no. 401-56-3-1.  
Welding joints must be done with the WIG-inert protective atmosphere welding system with welding material 1.7734.2. Finally the actuation shaft must be finished with primer and paint RAL 7003. After assembly, you must check that both airbrakes are completely locked and past the over center. This can be done by visually inspection through the hole in the root rib both airbrake actuators must be positioned against their stops.
