Subject: Securing of L'Hotellier quick release attachments according to LTA 93-001/2 edited by the German Luftfahrtbundesamt.

Effectivity: Glasflügel 604, all serial numbers.

93-001/2 L'Hotellier

Subject:
Inspection and Modification of L'Hotellier quick release attachment

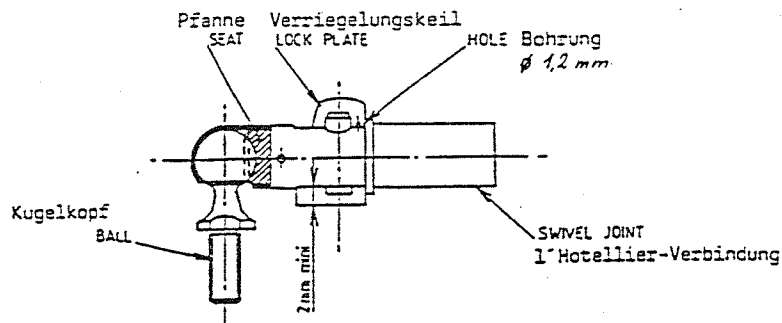
figure 1

- 1) If the joints are not yet equipped with safety pins (e.g. 1'H 140-31 made by Hotellier), these safety pins have to be retrofitted. In certain cases it may become necessary to rebores the hole in the lock plate, which is provided for visual inspection, to $\phi 1.2$ mm so that the safety pin can be inserted (see figure 1).

The ball and swivel joints with lock plates must be secured. For this purpose, the following actions are to be accomplished:

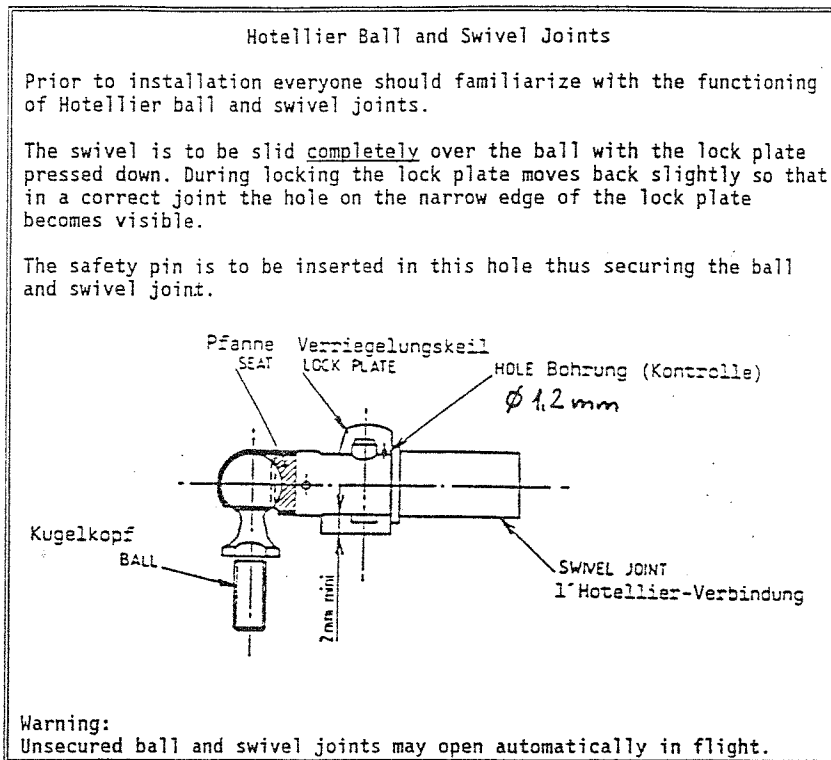
- b). If older Flight Manuals do not contain information on l'Hotellier ball and swivel joints, the following paragraph (probably on a new page) is to be included in the Flight Manual under the Section "Rigging", if the l'Hotellier joint is or is to be secured by means of a safety pin:

These entries in the Flight Manual can be made in writing or as a copy indicating the AD-No. 93-001.
