Reference: Sailplane Type: Standard Libelle  
Standard Libelle 201B  
German Data Sheet No. 251,  
U.S. Type Certificate G12EU, Data Sheet  
revision 4 dated February 5th 1973,  
Serial-No. 1-392 and 398.

Subject: Reinforcement of rudder yoke stops

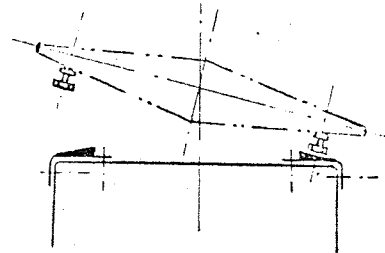
Reason: Due to constant impact by the adjustment  
screws of the rudder yoke, its stops on  
the wheel well were damaged.

Remarks: Sand bonding areas using 120 grade sand  
paper. Glue FRP angles to wheel well so  
that the flat screw heads of the rudder  
yoke meet the angles with their full area.  
Fasten each FRP angle with additional 4 self  
tapping screws to the wheel well.  
Check rudder deflection of  $25^{\circ}$  ( $\pm 1^{\circ}$ ) on  
both sides by adjusting rudder yoke screws.
