Reference: Sailplane model
H 301 and H 301 Libelle, German Data Sheet No. 251,
from Serial No. 2 and on, however, Serial
No. 2 to 85 only, if the elevator actuator
bracket has welded assembly guides instead of
screwed guides.
Standard Libelle and
Standard Libelle 201 B, German Data Sheet No. 251,
all Serial Numbers,
Club Libelle 205, German Data Sheet Nr. 304, up to
Serial Number 107,
Hornet, up to Serial Number 3

Subject: Reinforcement of the elevator assembly guides.

TECHNISCHE MITTEILUNG
TECHNICAL NOTE

201-20
Nr: 205-6, 206-1
301-30

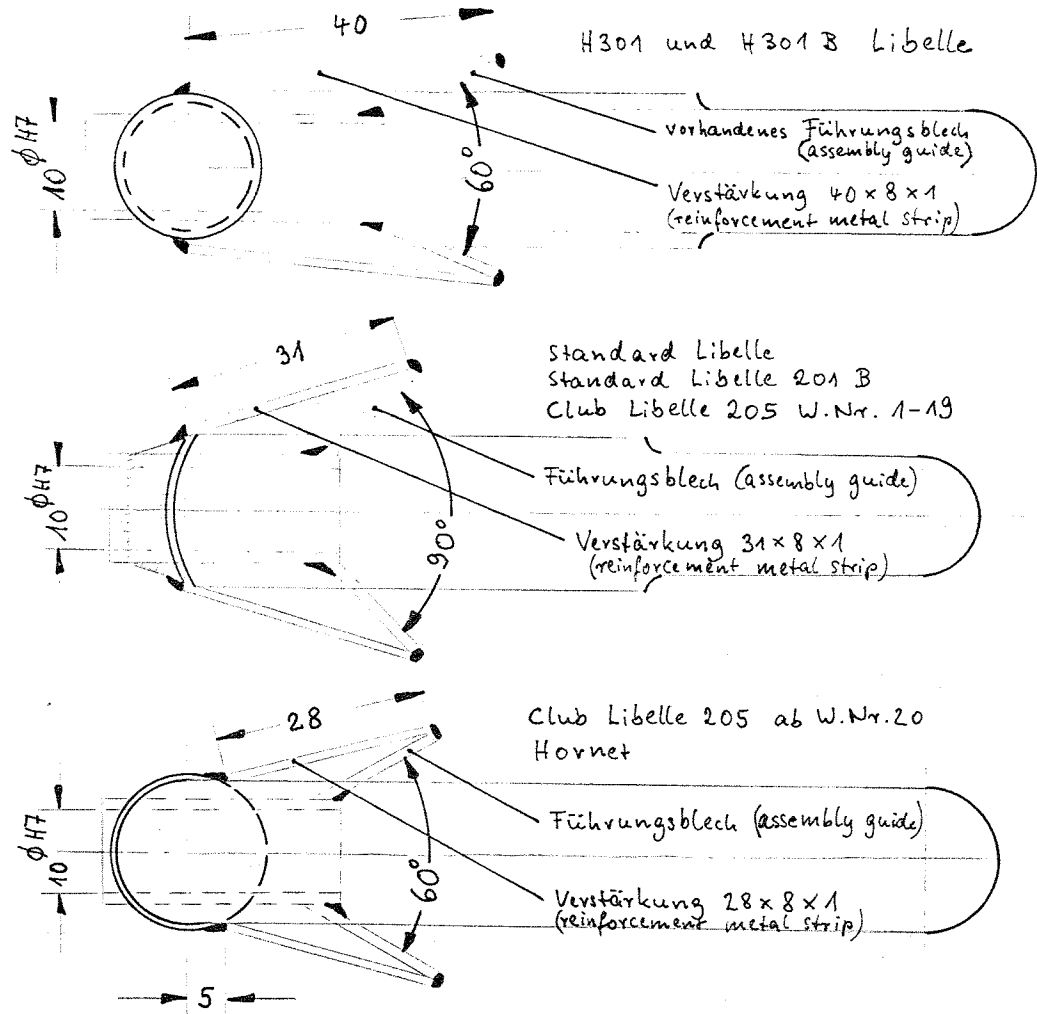
Reason: Careless assembly of the tailplane caused damaged
elevator assembly guides, resulting in a possible
improper assembly of the tailplane and loss of
elevator control.

Method: 1. With a 5 x powered magnifier visually inspect
the assembly guides for distortion, bending
and/or for cracks in the welded seam.
2. If damage is found replace the bracket
immediately with a bracket to be reinforced
according to method 4.
3. If no damage is found replace the bracket with
a bracket to be reinforced according to
method 4 before the date quoted in "Urgency".
4. Weld in two sheet metal strips according to the
following drawings to reinforce both guides.
(see next page)

Sheet metal to specification 1.7214.4 or 1.7734.4, welding material to specification 1.7734.2 or 1.7324.0, welding process WIG (Wolfram-Inert-Gas). After removing the bracket insert a pin 10 mm ϕ into the tube instead of the actuator pin to prevent warping during welding. It should be possible to insert this pin simply by hand. Remove the pin after the bracket has cooled down. Preserve the bracket again (recommended single component primer B 1742 from Lackfabrik Bäder and nitro lacquer). Fit the bracket to the tailplane and pay attention to the 2 washers between bracket and ball bearings.
