Subject: Elevator Linkage at the base of the stick

Affected: Glider-Model: Standard Libelle  
Standard Libelle 201 B

Reason: Failure of a Linkage

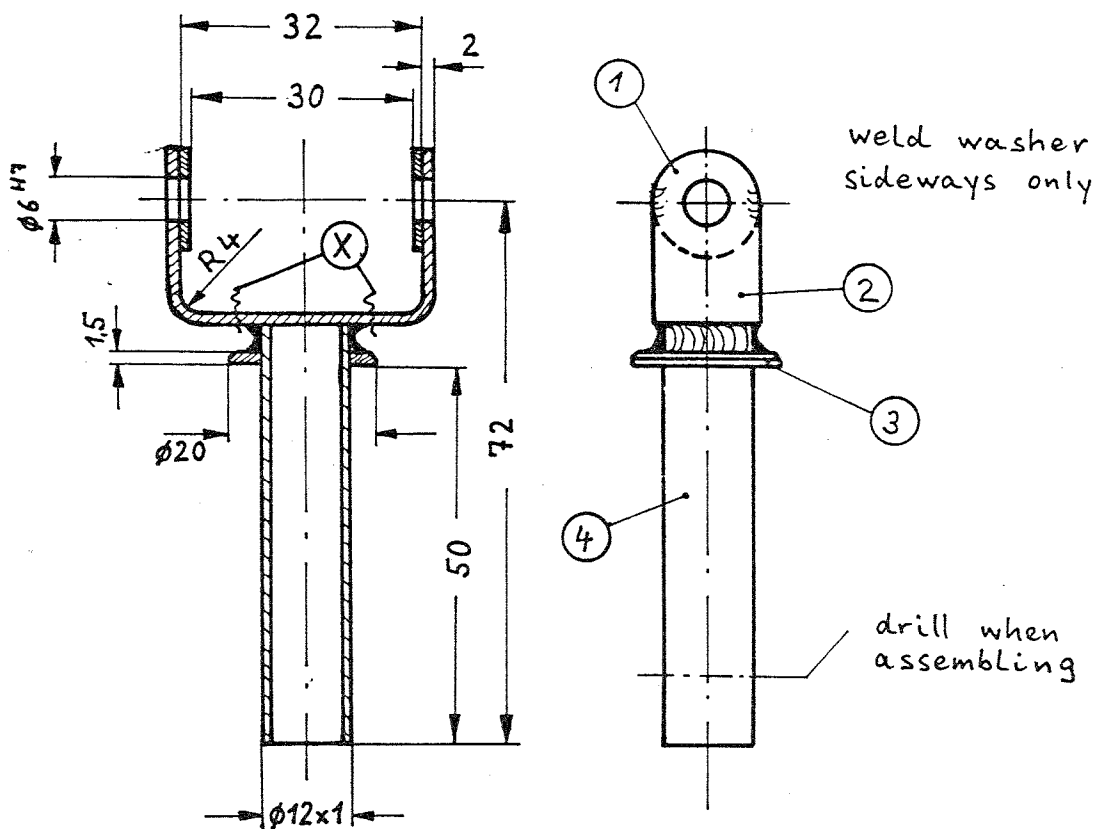
Action 1: The Elevator Linkage at the base of the stick (see modified drawing No. 301-41-4/2) must be inspected carefully by means of a magnifying glass (magnification at least 5x) for possible cracks near the welded seam. This inspection must be made immediately and again following the application of high loads to the glider (e.g. hard Landing or ground loops). If cracks are found the glider must not be flown until the defective part has been replaced.

(X) Position of possible cracks on original Elevator Linkage

Action 2: The Elevator Linkage at the base of the stick must be replaced by a modified part in accordance with drawing No. 301-41-4/2. Replacement must in all cases be effected until November 1st 1980.
