Subject : Elevator drive

Affected : Sailplanes model "Club-Libelle 205" } F.R.G. Type Certif.
"Hornet" } No. 304
"Mosquito" } F.R.G. Type Certif.
"Glasflügel 304" } No. 318
- all variants, all serial numbers

HR - Antrieb
Elevator drive bracket

205-33-9

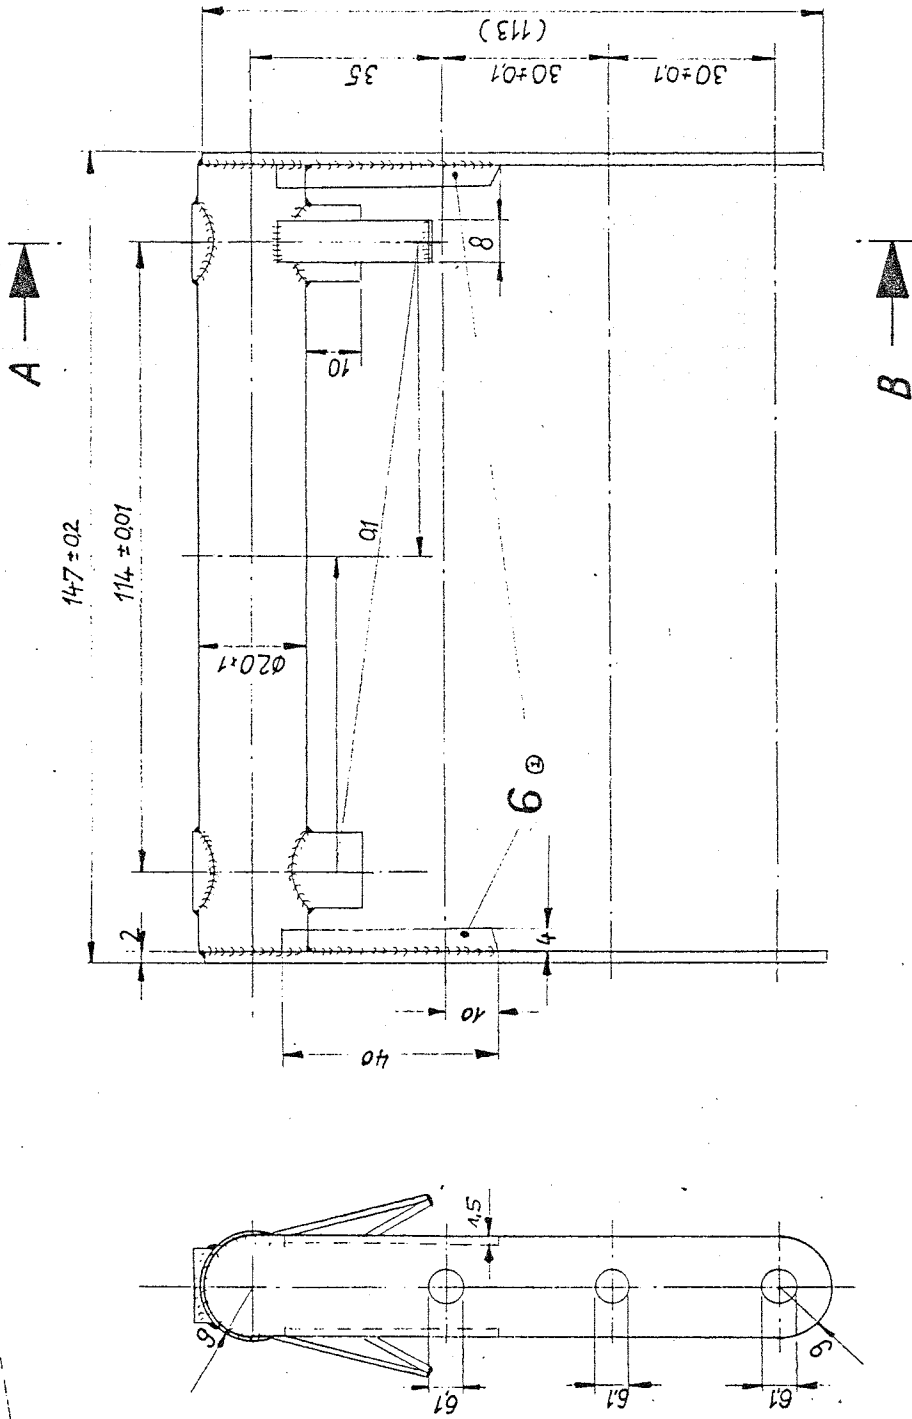
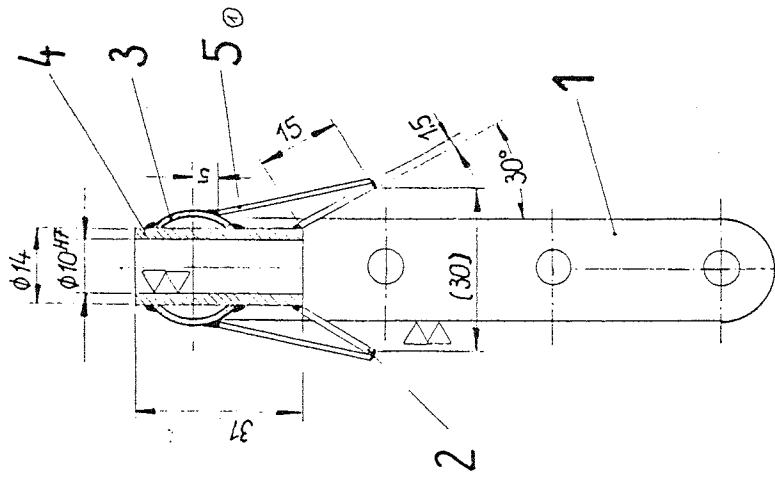
Reason : Difficulties in the control of the sailplane were encountered when an elevator drive bracket broke on one side in flight.

Actions : 1. On sailplanes having an earlier type elevator drive bracket (without reinforcements identified as part (5), modif. 2, on the drawing shown overleaf), a visual inspection for possible cracks in the bracket arms must be carried out. It must also be checked that the bracket arms are not twisted out of line.
2. On sailplanes having an earlier type elevator drive bracket (without reinforcements), the bracket must either be reinforced according to the drawing shown overleaf or be replaced by a reinforced bracket. When the tailplane is re-assembled, it must be made sure that the correct number of spacing washers are fitted between the bracket arms and the ball bearings (tag washers when removing the bracket).

Materials : The reinforced elevator drive bracket, manufactured according to drawing No. 205-33-9 (modification 2) or the additional metal strips with welding wire 1.7734.2 may be obtained from:
Hansjörg Streifeneder
Glasfaser-Flugzeug-Service GmbH
Hofener Weg
7431 Grabenstetten
Federal Republic of Germany

Note : Welding according to drawing No. 205-33-9 (modification 2) must be done by a licensed aircraft welder.
Accomplishment of action 1 must be done by a skilled person.
Accomplishment of action 2 must be entered in the sailplane's log by a licensed inspector.

Fitting drilled with drilling jig
Ream drilled hole 10H7 with device
after welding
For dimensions see DIN 7168 medium range

TIG welding with filler metal 1.7734.2 ge-
schwellig. Grundiert mit Wash-Primer 42002 + Härter
40018. Decklackierung mit Nitro-Lack grau RAL 7003,
RAL 7003 or cadmium-plated
