<u>Sailplane model:</u>	H 301 Libelle und H 301 B Std.Libelle, Std.Lib. 201 B, Std.Lib. 203 Club Libelle 205 und Hornet Kestrel Glasflügel 604 BS 1	ATC No. 251 251 304 276 281
-------------------------	--	---

- Subject : Glass fiber laminate covering the spar stub fittings
- Affected : As listed above
- Urgency : Inspection for a separation of the laminate on the occasion of each annual inspection

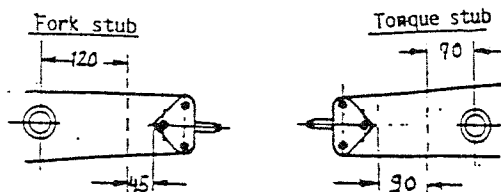
2. If corrosion was found on the fitting, proceed as follows:
First remove gelcoat from spar stub (if such was applied by the manufacturer) and remove laminate as shown in the sketch (such preparing the area to be scarfed later on) -

make sure that the spar flange rovings and the laminate connecting the upper and lower stub halves are never been sanded. Furthermore remove any laminate adhering to the fitting.

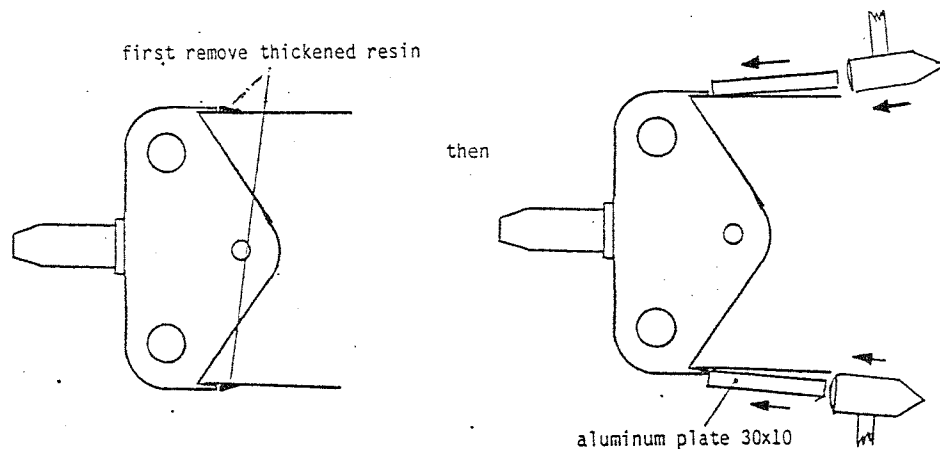
If there is suspicion that there is corrosion on the inner side of the fitting, it has to be removed as follows:

Drive out hollow rivets imbedded in the spar flanges - but make sure that a counter weight is held against the driving force, Thereafter, with rivets removed, carefully loosen and extract the fitting with the aid of an aluminum plate - see sketch.

Next sandblast the fitting (Using only approved material) and apply a fresh corrosion protection. Then carefully smooth the spar stub (using a 400 grid sand paper), apply a thin coat of resin, push fitting fully home and install hollow rivets. The step between fitting and stub and between connecting glass layers should be filled up using thickened resin.
