Reference: Sailplane model  
H 301 and H 301 Libelle, German Data Sheet No. 251,  
from Serial No. 2 and on, however, Serial  
No. 2 to 85 only, if the elevator actuator  
bracket has welded assembly guides instead of  
screwed guides.  
Standard Libelle and  
Standard Libelle 201 B, German Data Sheet No. 251,  
all Serial Numbers,  
Club Libelle 205, German Data Sheet Nr. 304, up to  
Serial Number 107,  
Hornet, up to Serial Number 3

Subject: Reinforcement of the elevator assembly guides.

TECHNISCHE MITTEILUNG  
TECHNICAL NOTE

201-20  
Nr: 205-6, 206-1  
301-30

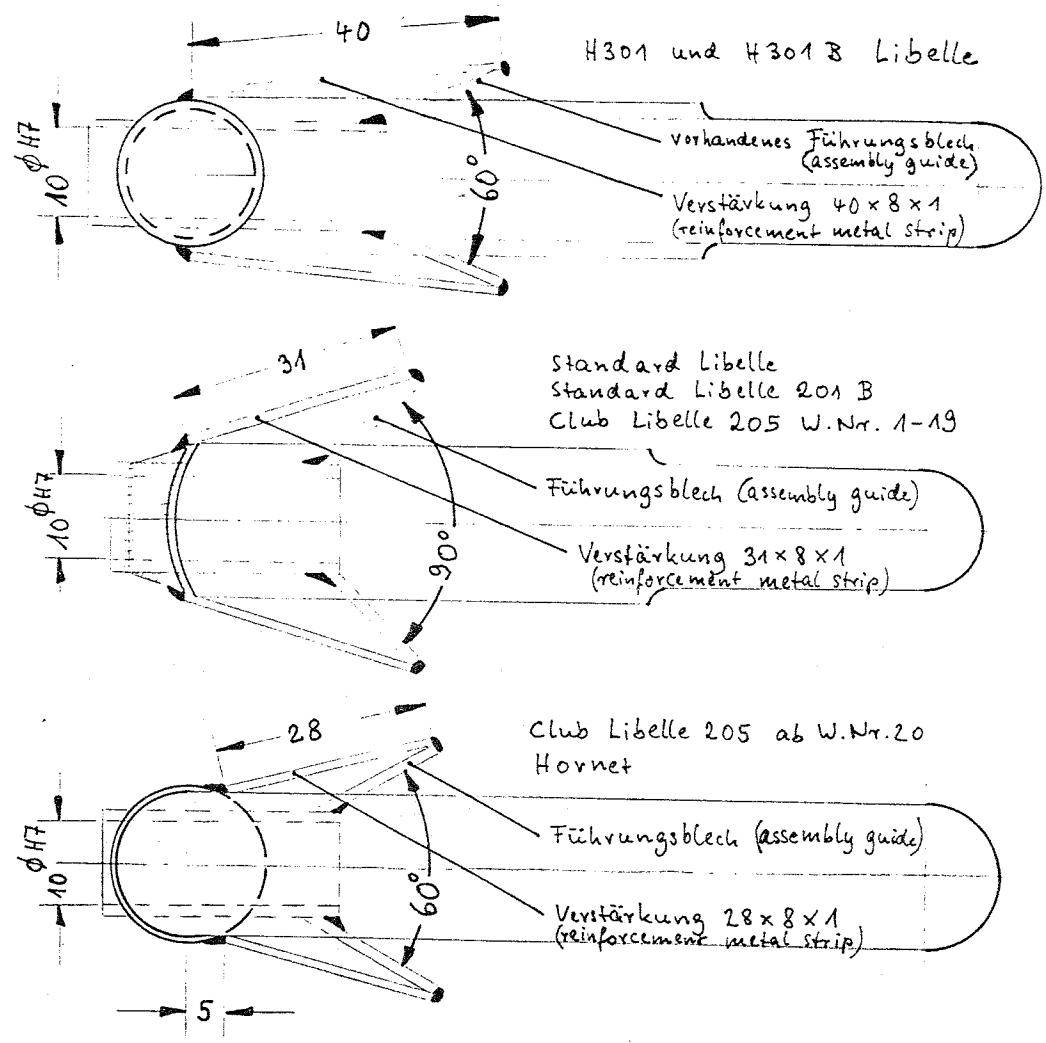
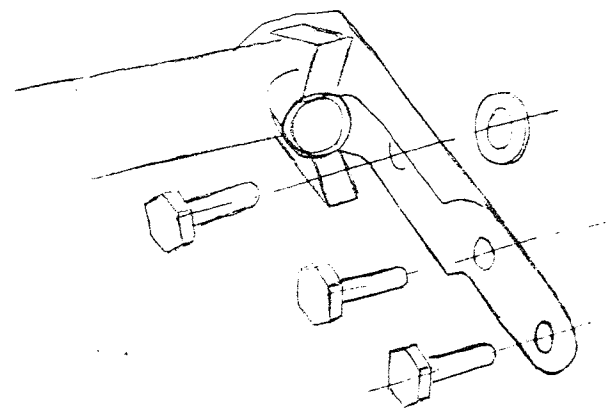
Reason: Careless assembly of the tailplane caused damaged  
elevator assembly guides, resulting in a possible  
improper assembly of the tailplane and loss of  
elevator control.

Method: 1. With a 5 x powered magnifier visually inspect  
the assembly guides for distortion, bending  
and/or for cracks in the welded seam.  
2. If damage is found replace the bracket  
immediately with a bracket to be reinforced  
according to method 4.  
3. If no damage is found replace the bracket with  
a bracket to be reinforced according to  
method 4 before the date quoted in "Urgency".  
4. Weld in two sheet metal strips according to the  
following drawings to reinforce both guides.  
(see next page)

Sheet metal to specification 1.7214.4 or 1.7734.4, welding material to specification 1.7734.2 or 1.7324.0, welding process WIG (Wolfram-Inert-Gas). After removing the bracket insert a pin 10 mm  $\phi$  into the tube instead of the actuator pin to prevent warping during welding. It should be possible to insert this pin simply by hand. Remove the pin after the bracket has cooled down. Preserve the bracket again (recommended single component primer B 1742 from Lackfabrik Bäder and nitro lacquer). Fit the bracket to the tailplane and pay attention to the 2 washers between bracket and ball bearings.
