Affected : Sailplane model "Kestrel"
F.R.G. Type Certificate No. 276
- all serial numbers -

Subject : Rudder gimbal drive
- rear actuator arm -

TECHNICAL NOTE NO. 401 - 19

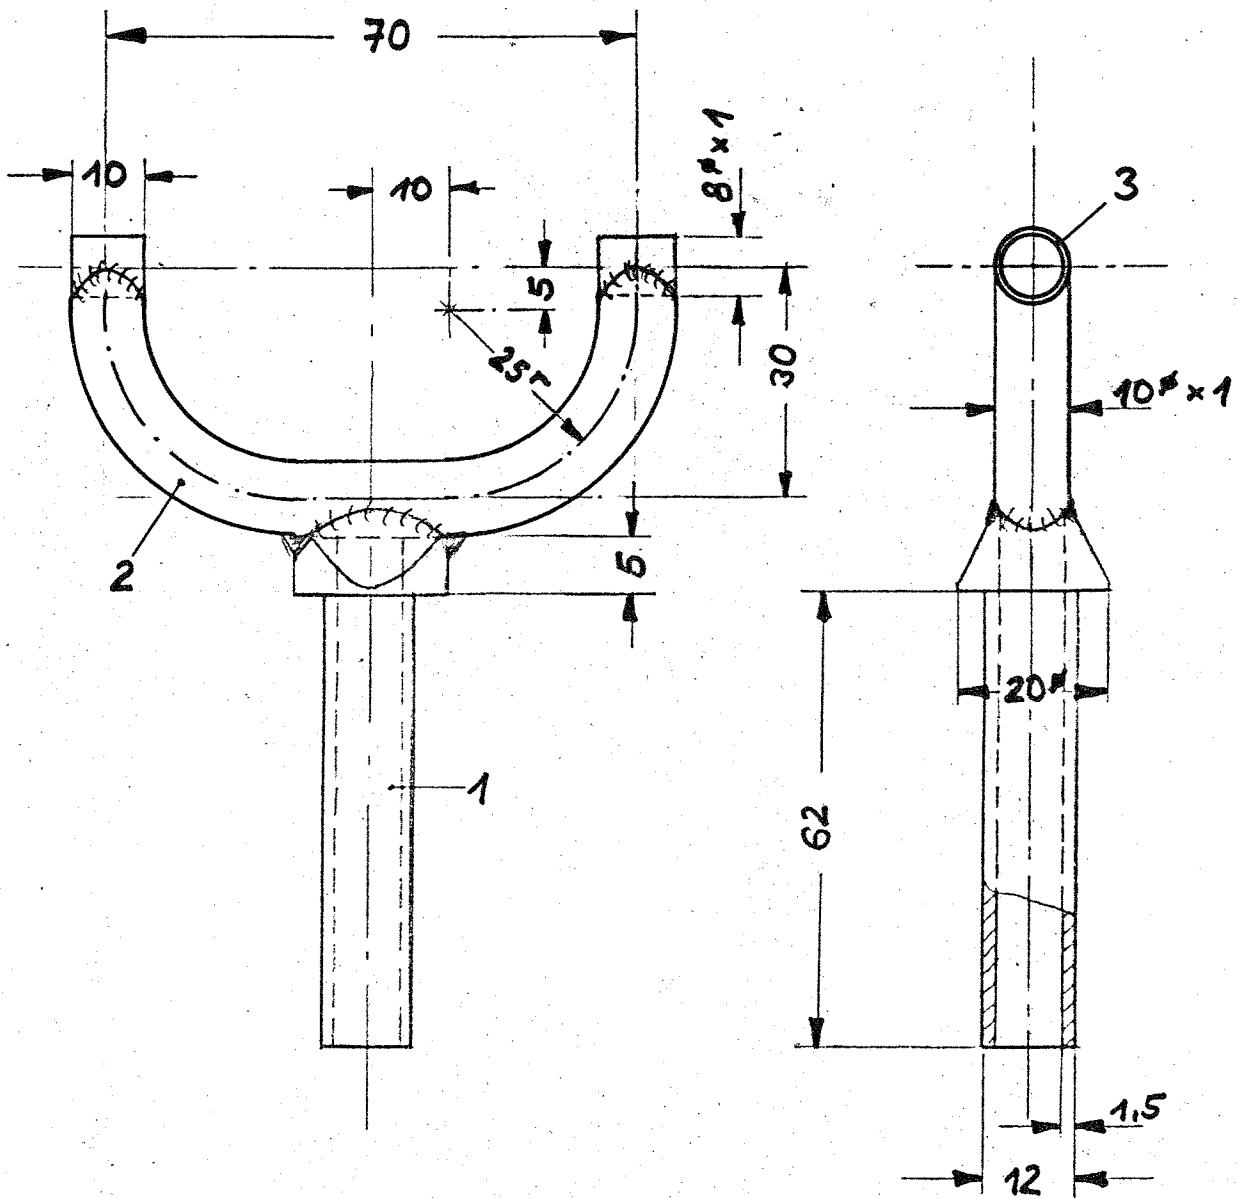
301-45-13

Reason : Failure of the actuator arm caused by loads applied
when regularly lifting the fuselage by its rudder.
and/or when fuselage has broken.

Actions : The faulty part, made according to drawing No. 301-45-10,
must be replaced by an improved actuator arm, made in
accordance with drawing No. 301-45-13.

Im WIG-Verfahren mit Zusatzwerkstoff 1.7734.2 geschweißt. Grundiert mit Wash-Primer 42002 + Härter 40018. Decklackierung mit Nitro-Lack grau RAL 7003.

Spannungsfrei gegläht
bei 580°C 4 Std.
unter Schutzgas
