<u>Sailplane model:</u>	H 301 Libelle und H 301 B	ATC No. 251
	Std.Libelle, Std.Lib. 201 B, Std.Lib. 203	251
	Club Libelle 205 und Hornet	304
	Kestrel	276
	Glasflügel 604	281
	BS 1

- Subject : Glass fiber laminate covering the spar stub fittings
- Affected : As listed above
- Urgency : Inspection for a separation of the laminate on the occasion of each annual inspection

- Reason : Separation of laminate from wing attachment fittings allowing the ingress of moisture which in turn may lead to corrosion
- Actions : 1. Inspection for a separation of the laminate at each annual inspection.  
A separation of the laminate is recognized by gaps showing at the face of the spar stub(s).  
If gaps are found, the fitting must be checked for corrosion by carefully lifting the laminate.  
If the fitting is free from corrosion, the laminate must be rebonded to the fitting as follows:  
Place wing leading edge down on trestles. Using thin wooden wedges force the gap to open and, with the aid of a syringe (internal diameter of needle to be 0.8 mm), carefully inject thickened resin into the cavity (Scheufler resin No. 285, mixed 100 :38 with hardener No. 285 and "Aerosil" added).  
Next remove wed

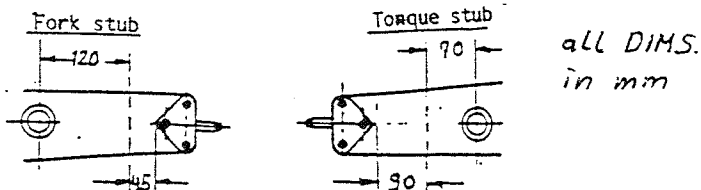
2. If corrosion was found on the fitting, proceed as follows:  
First remove gelcoat from spar stub (if such was applied by the manufacturer) and remove laminate as shown in the sketch (such preparing the area to be scarfed later on) -

make sure that the spar flange rovings and the laminate connecting the upper and lower stub halves are never been sanded. Furthermore remove any laminate adhering to the fitting.

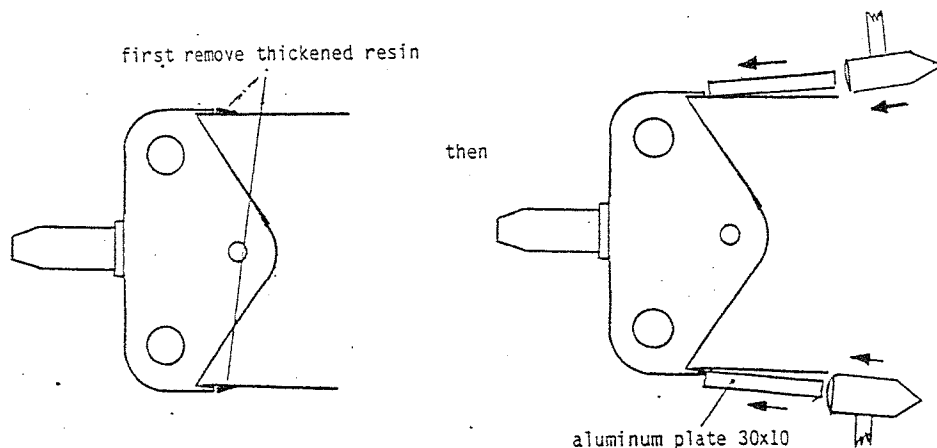
If there is suspicion that there is corrosion on the inner side of the fitting, it has to be removed as follows:

Drive out hollow rivets imbedded in the spar flanges - but make sure that a counter weight is held against the driving force, Thereafter, with rivets removed, carefully loosen and extract the fitting with the aid of an aluminum plate - see sketch.

Next sandblast the fitting (Using only approved material) and apply a fresh corrosion protection. Then carefully smooth the spar stub (using a 400 grid sand paper), apply a thin coat of resin, push fitting fully home and install hollow rivets. The step between fitting and stub and between connecting glass layers should be filled up using thickened resin.
