<u>Sailplane model:</u>	H 301 Libelle und H 301 B	ATC No. 251
	Std.Libelle, Std.Lib. 201 B, Std.Lib. 203	251
	Club Libelle 205 und Hornet	304
	Kestrel	276
	Glasflügel 604	281
BS I

Subject : Glass fiber laminate covering the spar stub fittings

Urgency : Inspection for a separation of the laminate on the occasion of each annual inspection

Reason : Separation of laminate from wing attachment fittings allowing the ingress of moisture which in turn may lead to corrosion

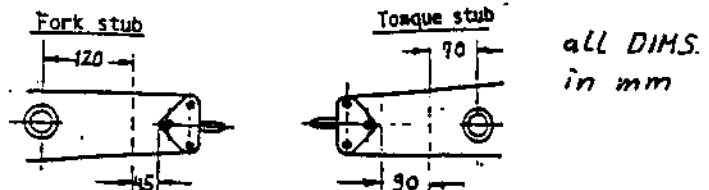
2. If corrosion was found on the fitting, proceed as follows:  
First remove gelcoat from spar stub (if such was applied by the manufacturer) and remove laminate as shown in the sketch (such preparing the area to be scarfed later on) -

make sure that the spar flange roving and the laminate connecting the upper and lower stub halves are never been sanded. Furthermore remove any laminate adhering to the fitting.

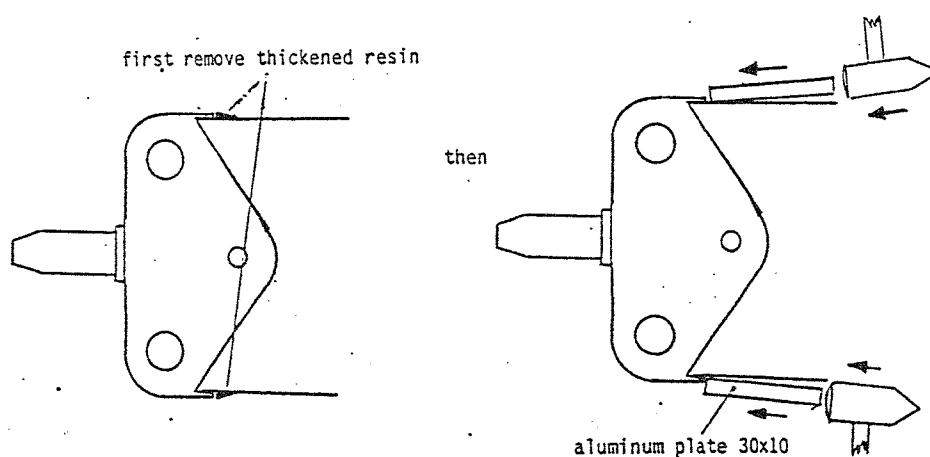
If there is suspicion that there is corrosion on the inner side of the fitting, it has to be removed as follows:

Drive out hollow rivets imbedded in the spar flanges - but make sure that a counter weight is held against the driving force, Thereafter, with rivets removed, carefully loosen and extract the fitting with the aid of an aluminum plate - see sketch.

Next sandblast the fitting (Using only approved material) and apply a fresh corrosion protection. Then carefully smooth the spar stub (using a 400 grid sand paper), apply a thin coat of resin, push fitting fully home and install hollow rivets. The step between fitting and stub and between connecting glass layers should be filled up using thickened resin.
