Subject: Elevator control rod in vertical stabilizer  
P/N: 205-46-9, 401-46-24, 501-46-11 und 604-46-13,-15,-16

| Glasfaser-Flugzeug-Service GmbH<br>Hansjörg Streifeneder<br>Hofener Weg 61<br>72582 Grabenstetten | <b>Technical Note</b><br>TN 201-40, TN 205-27<br>TN 206-26, TN 303-25<br>TN 304-12, TN 401-30<br>TN 501-10, TN 604-11 | Page: 02 of 05 |
| <u>Action:</u> | Inspection and replacement of elevator control rod | |

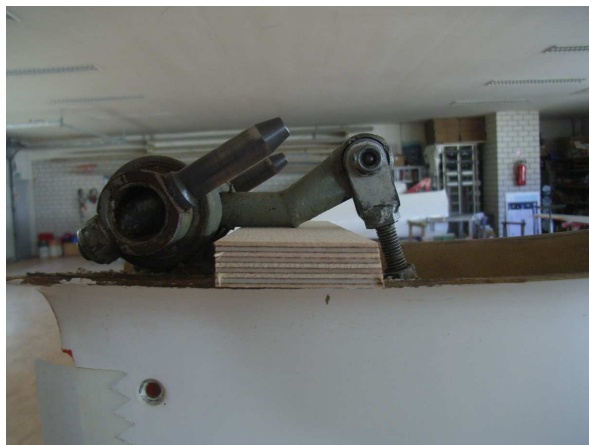
Picture 1:

| <u>Action 1:</u> | <p>Inspection of elevator control rod:</p> <ol style="list-style-type: none"> <li>1. Install horizontal stabilizer, check elevator deflection in accordance with Table1. Note readings. Remove horizontal stabilizer.</li> <li>2. With horizontal stabilizer removed, lock elevator control lever on top of vertical stabilizer by using a wooden block (150 x 40 x 12 mm) in the „lever-up“-position (control stick fwd.) ( see picture1)</li> </ol> <p><b><u>CAUTION: Extreme care should be used that the wooden block is correctly installed on both top edges of the vertical stabilizer to avoid damage to stabilizer structure.</u></b></p> <ol style="list-style-type: none"> <li>3. By using a springscale, apply a force of 210 N for minimum10 seconds to the stick in aft direction. Position the scale above of the trim knob. (see picture 2)</li> <li>4. After removal of wood block, install horizontal stabilizer.</li> <li>5. Check elevator deflection i.a.w. table 1. In case of different readings between measurements before and after the pull-test, action 2 must be carried out before next flight.</li> </ol> | |
