<u>Sailplane model:</u>	H 301 Libelle und H 301 B Std.Libelle, Std.Lib. 201 B, Std.Lib. 203 Club Libelle 205 und Hornet Kestrel Glasflügel 604 BS I	ATC No. 251 251 304 276 281
-------------------------	--	---

Subject : Glass fiber laminate covering the spar stub fittings

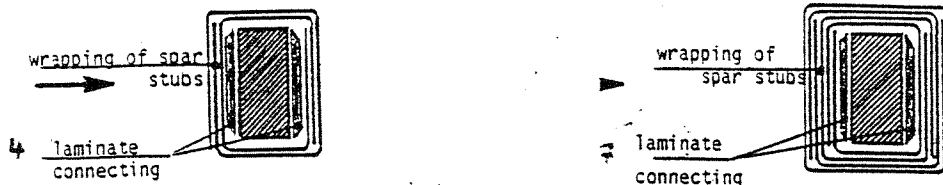
Next check whether the inner side of the latter has corroded.

This is recognized by a discolouring at the edges of the fitting and at the laminate next to it. If no so much damage is found and no change of the original condition can be assumed, clean the outer sides of the fitting (using a metal brush) and apply a fresh two component corrosion protection.

If there is suspicion that there is corrosion on the inner side of the fitting, it has to be removed as follows:

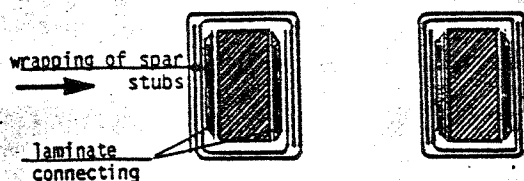
Fork stubs

wrapping of spar stubs  
laminate connecting

Finally the spar stub glass layers must be re-wrapped (note displacement of 15 mm) as shown in the sketch on page 1 (using Scheufler Epoxy resin No. 285, mixed with hardener No. 285, laminate to be covered by Nylon cloth).
