GLASFLÜGEL

AIRWORTHINESS DIRECTIVE

NO. 303 - 9

Subject Canopy emergency jettisoning system

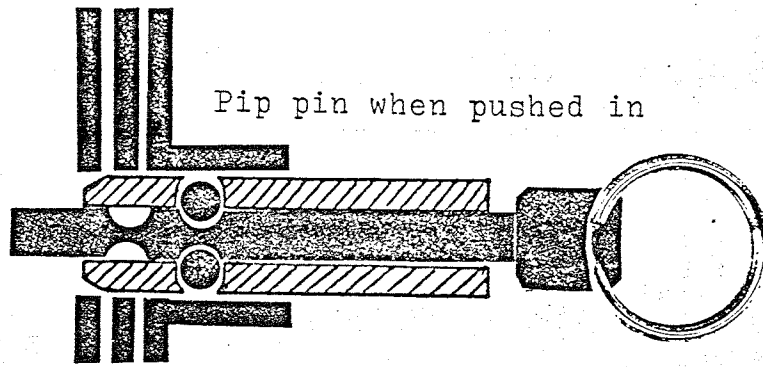
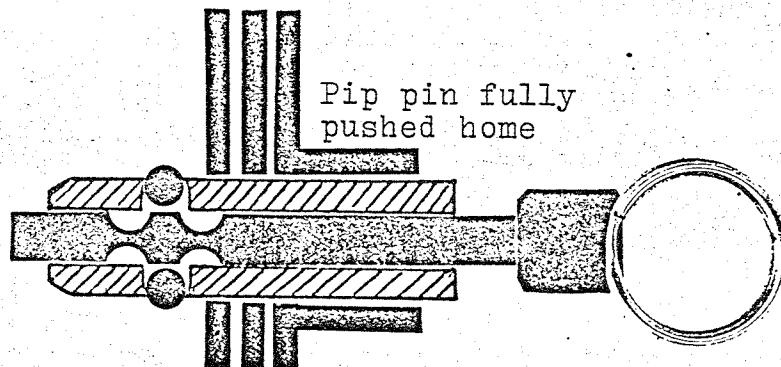
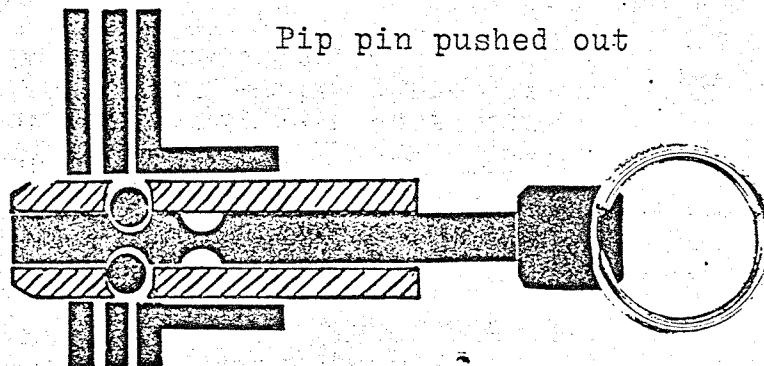
Reason During a routine check it was discovered, that either of the "Pip pins" of the canopy jettisoning system, which disengage when the red knob is pulled, could become jammed, if they had not been previously fully pushed home.

Fehlfunktion

Action On page 19, § 3.3, of the Flight Manual the following amendment must be inserted:
"Whenever the canopy emergency jettison knob is pulled and prior to each flight, if no locking thread is used, it should be ensured, that the Pip pins are fully pushed home, so that the locking balls are clear of and behind their fittings".
