<u>Sailplane model:</u>	H 301 Libelle und H 301 B Std.Libelle, Std.Lib. 201 B, Std.Lib. 203 Club Libelle 205 und Hornet Kestrel Glasflügel 604 BS 1	ATC No. 251 251 304 276 281
-------------------------	--	---

- Subject : Glass fiber laminate covering the spar stub fittings
- Affected : As listed above
- Urgency : Inspection for a separation of the laminate on the occasion of each annual inspection

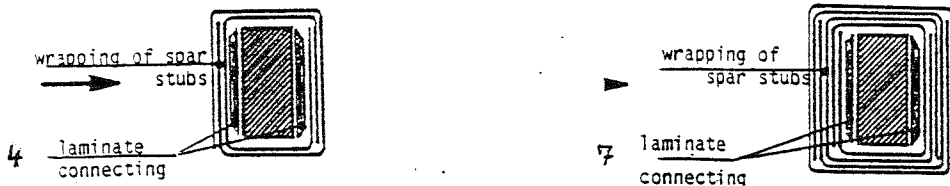
make sure that the spar flange rovings and the laminate connecting the upper and lower stub halves are never been sanded. Furthermore remove any laminate adhering to the fitting.

Next check whether the inner side of the latter has corroded. This is recognized by a discolouring at the edges of the fitting and at the laminate next to it. If no so much damage is found and no change of the original condition can be assumed, clean the outer sides of the fitting (using a metal brush) and apply a fresh two component corrosion protection.
