<u>Sailplane model:</u>	H 301 Libelle und H 301 B	ATC No. 251
	Std.Libelle, Std.Lib. 201 B, Std.Lib. 203	251
	Club Libelle 205 und Hornet	304
	Kestrel	276
	Glasflügel 604	281
	BS 1

- Subject : Glass fiber laminate covering the spar stub fittings
- Affected : As listed above
- Urgency : Inspection for a separation of the laminate on the occasion of each annual inspection

- Reason : Separation of laminate from wing attachment fittings allowing the ingress of moisture which in turn may lead to corrosion
- Actions : 1. Inspection for a separation of the laminate at each annual inspection.  
A separation of the laminate is recognized by gaps showing at the face of the spar stub(s).  
If gaps are found, the fitting must be checked for corrosion by carefully lifting the laminate.  
If the fitting is free from corrosion, the laminate must be rebonded to the fitting as follows:  
Place wing leading edge down on trestles. Using thin wooden wedges force the gap to open and, with the aid of a syringe (internal diameter of needle to be 0.8 mm), carefully inject thickened resin into the cavity (Scheufler resin No. 285, mixed 100 :38 with hardener No. 285 and "Aerosil" added).  
Next remove wed

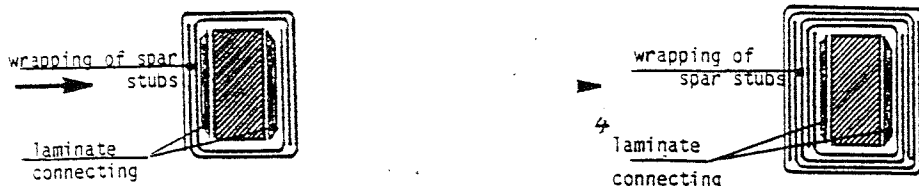
make sure that the spar flange rovings and the laminate connecting the upper and lower stub halves are never been sanded. Furthermore remove any laminate adhering to the fitting.

Next check whether the inner side of the latter has corroded. This is recognized by a discolouring at the edges of the fitting and at the laminate next to it. If no so much damage is found and no change of the original condition can be assumed, clean the outer sides of the fitting (using a metal brush) and apply a fresh two component corrosion protection.
